**DESIGN OF RESTORATION AND REVITALIZATION OF THE ROMAN AMPHITHEATRE, BYZANTINE FORUM & ROMAN BATHS, AND URBAN PATHWAYS IN THE CITY OF DURRËS**

**FINAL DESIGN**

**- Amphitheatre of Durrës - Legend**

DECAY MAPPING <b>- Amphitheatre of Durrës -</b> <b>MAPPING OF DECAY AND ALTERATIONS</b> Elevation 2 North	DATE: 2024 JUN sheet type <b>SECTION ELEVATION</b> sheet code <b>09</b> AM_DC_09 SCALE: 1:50
--	---

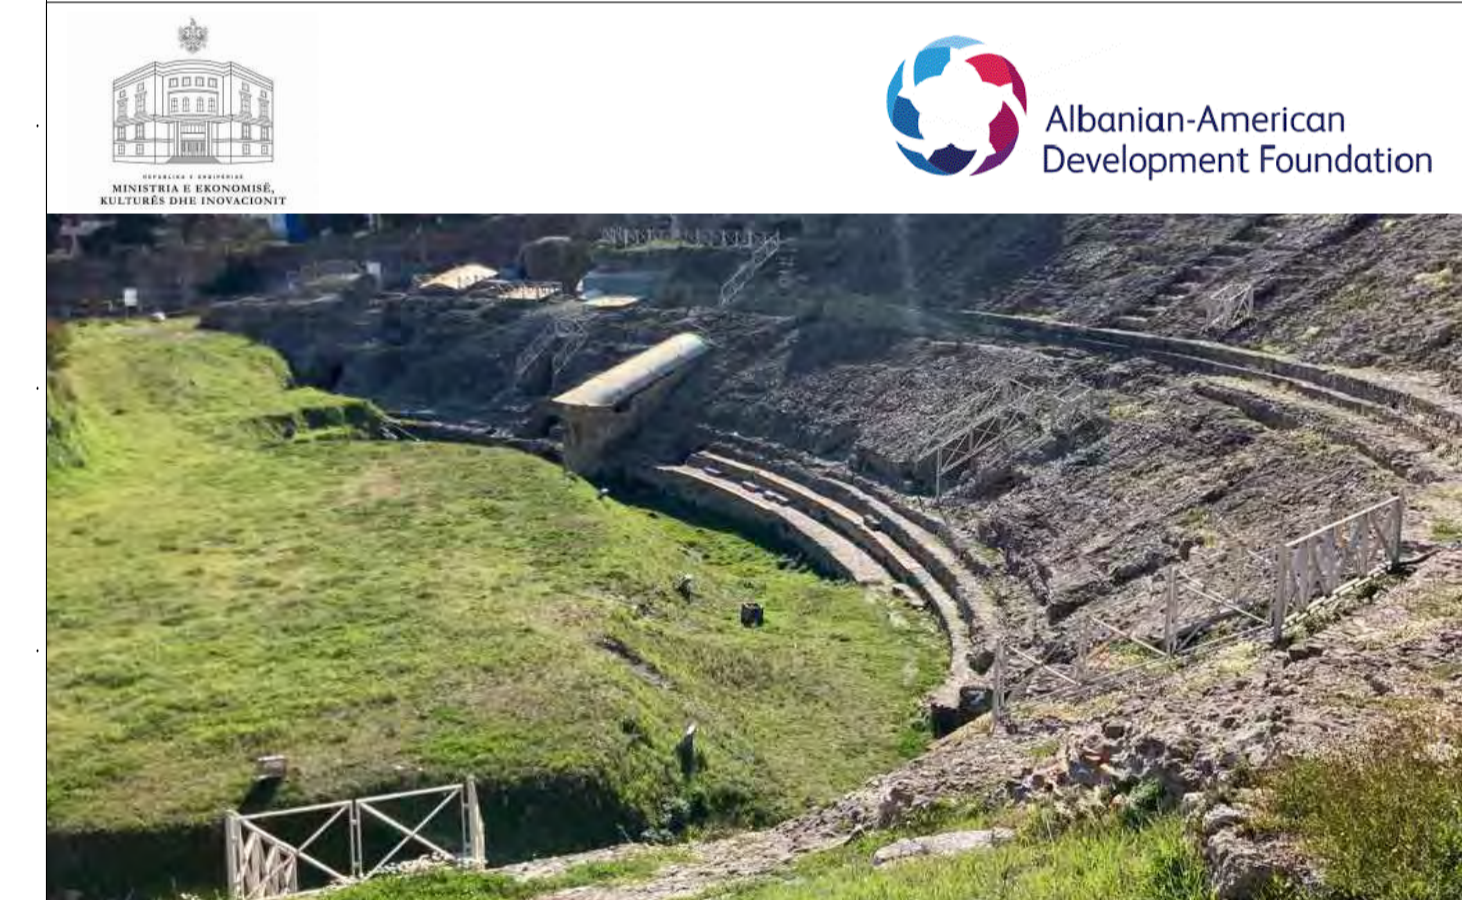
DECAY MAPPING - Amphitheatre of Durrës - MAPPING OF DECAY AND ALTERATIONS Elevation 2 South

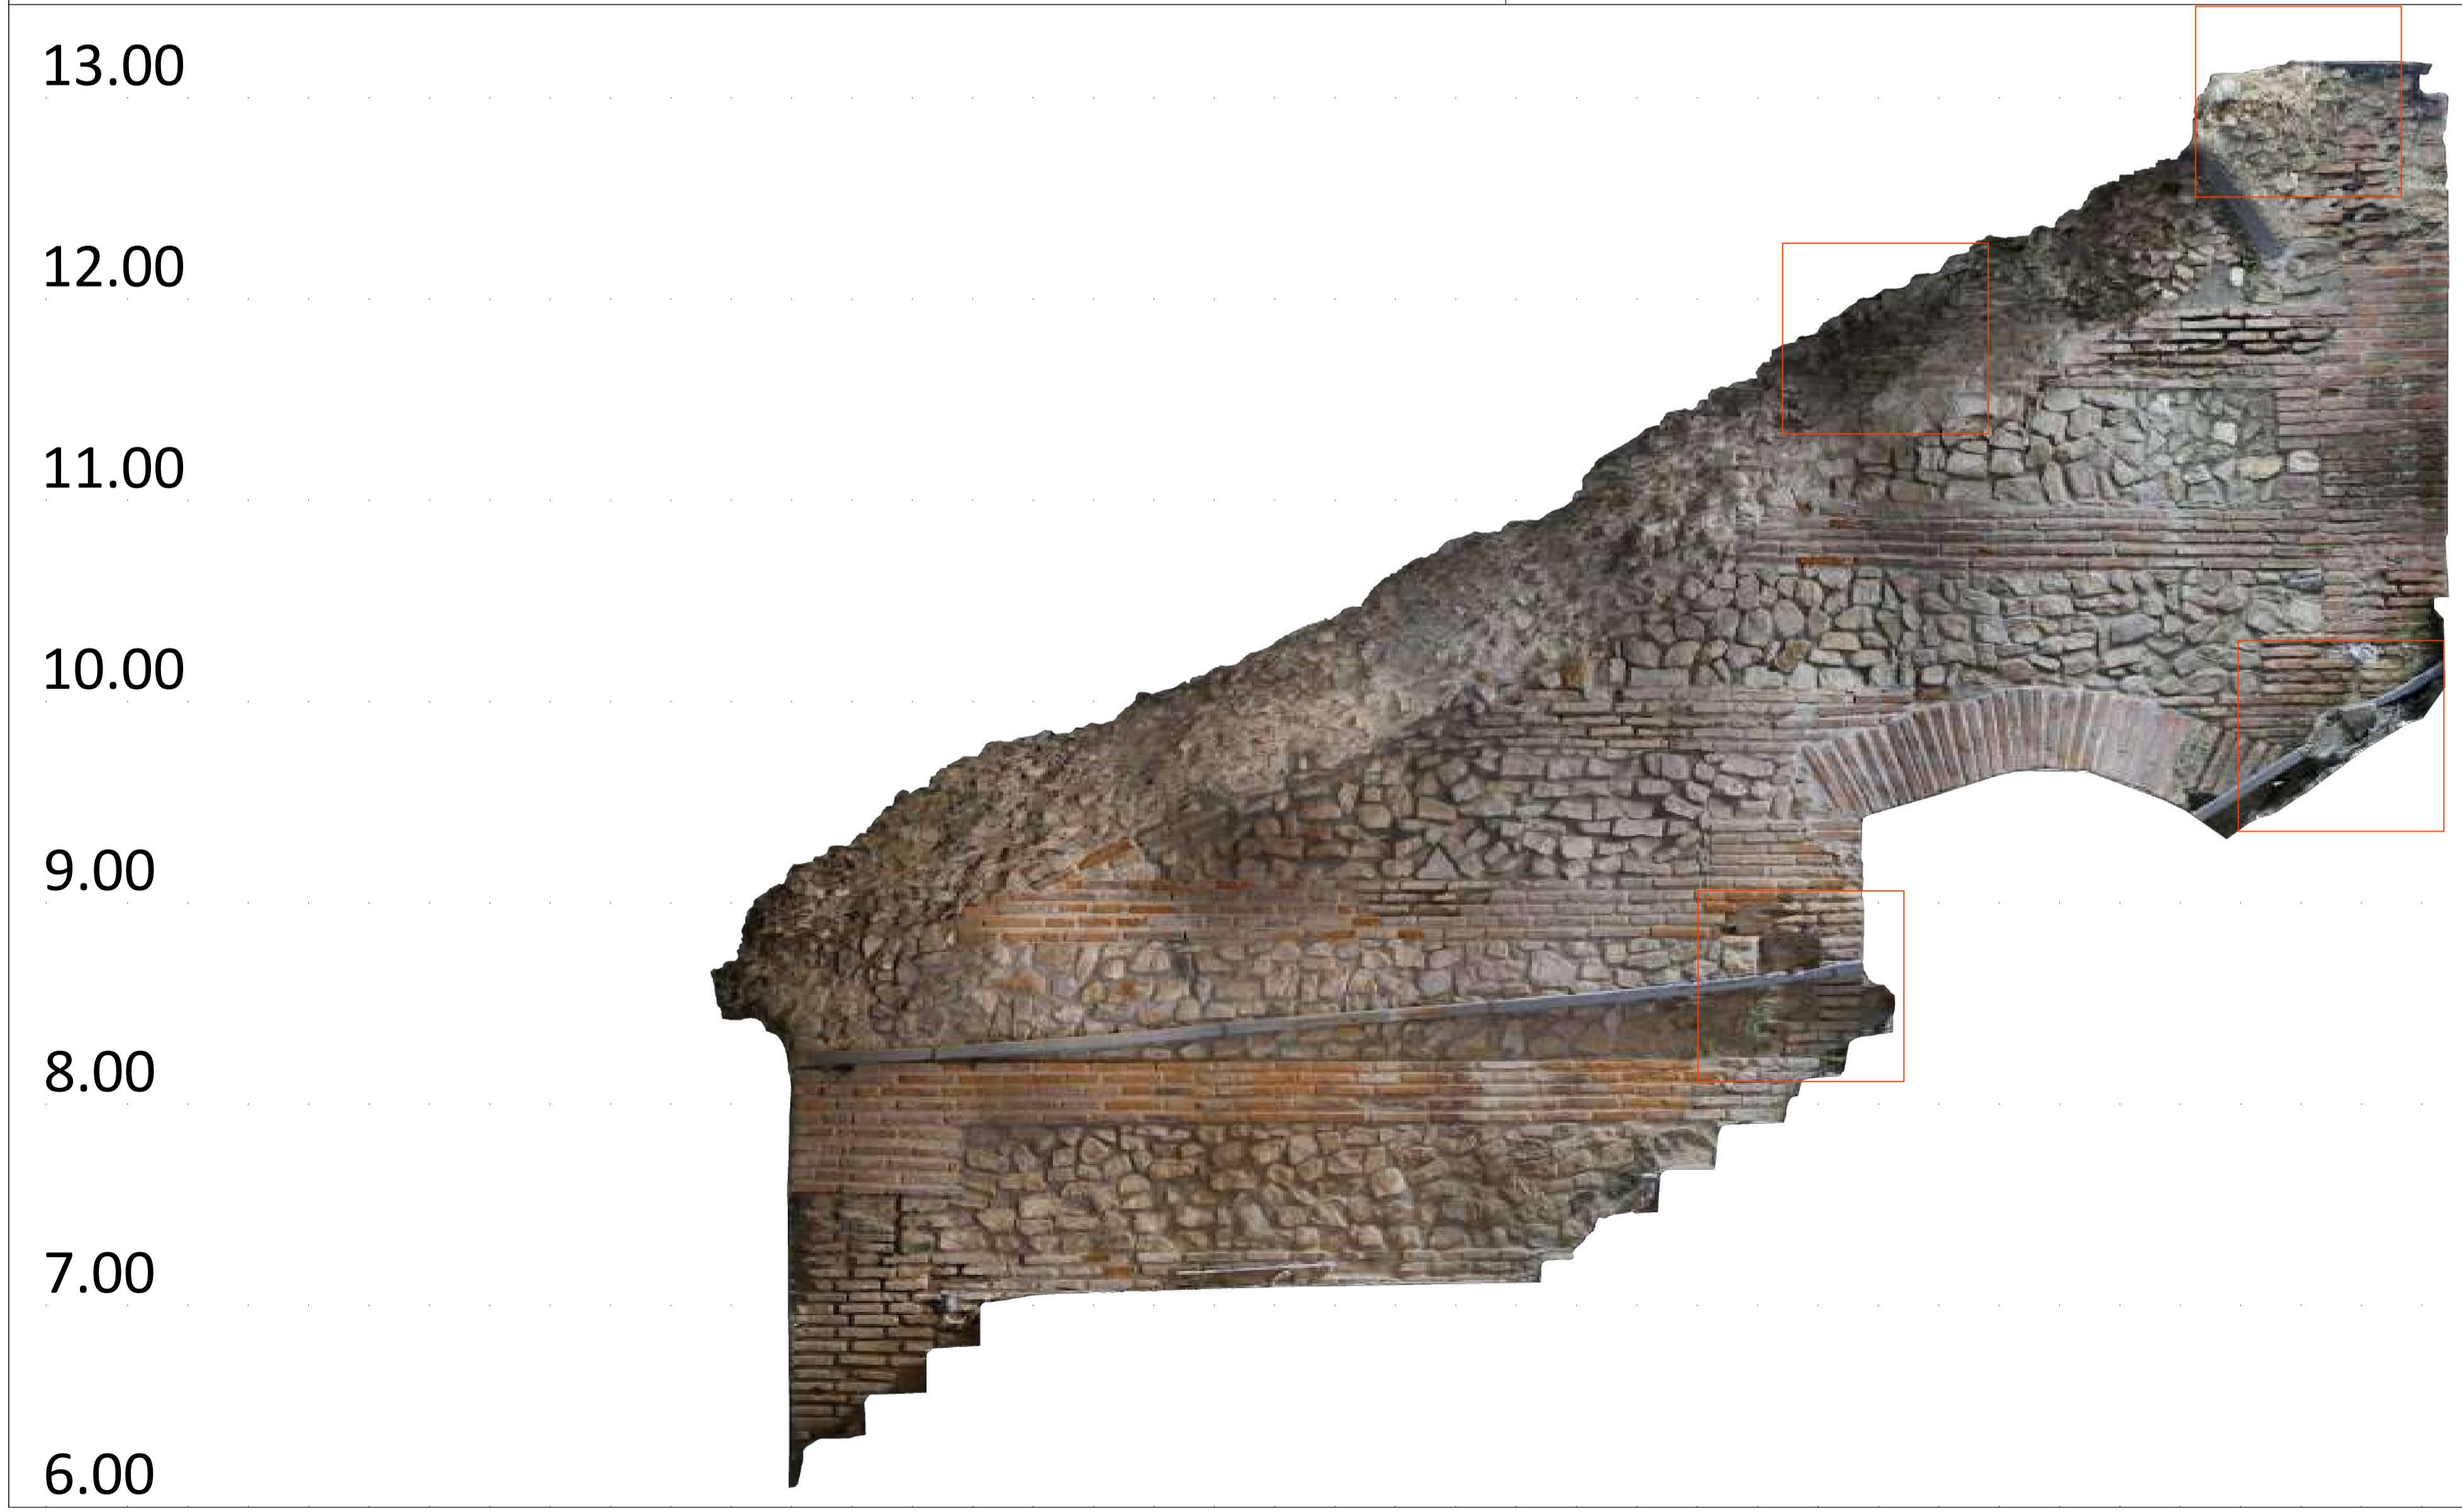
ELEVATION 3 south  
PRERJA 3 jug

- Amphitheatre of Durrës -  
MAPPING OF DECAY AND ALTERATIONS  
Elevation 3 South

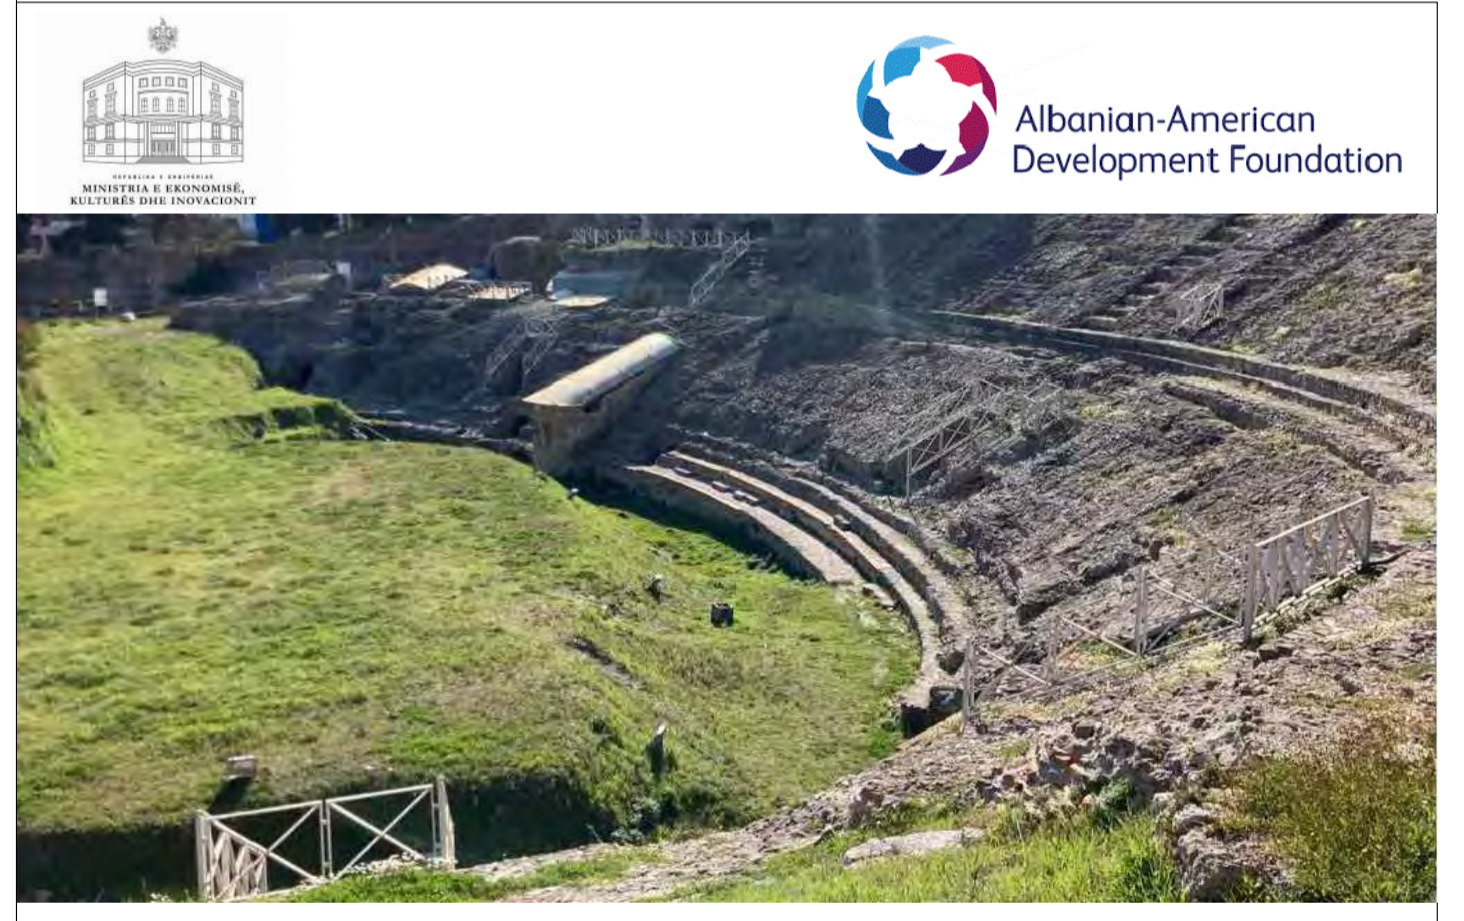
## ELEVATION 4 north\_det.02 PRERJA 4 veri\_det.02

DECAY MAPPING - Amphitheatre of Durrës -  
MAPPING OF DECAY AND ALTERATIONS  
Elevation 4 North - Elevation 4 South

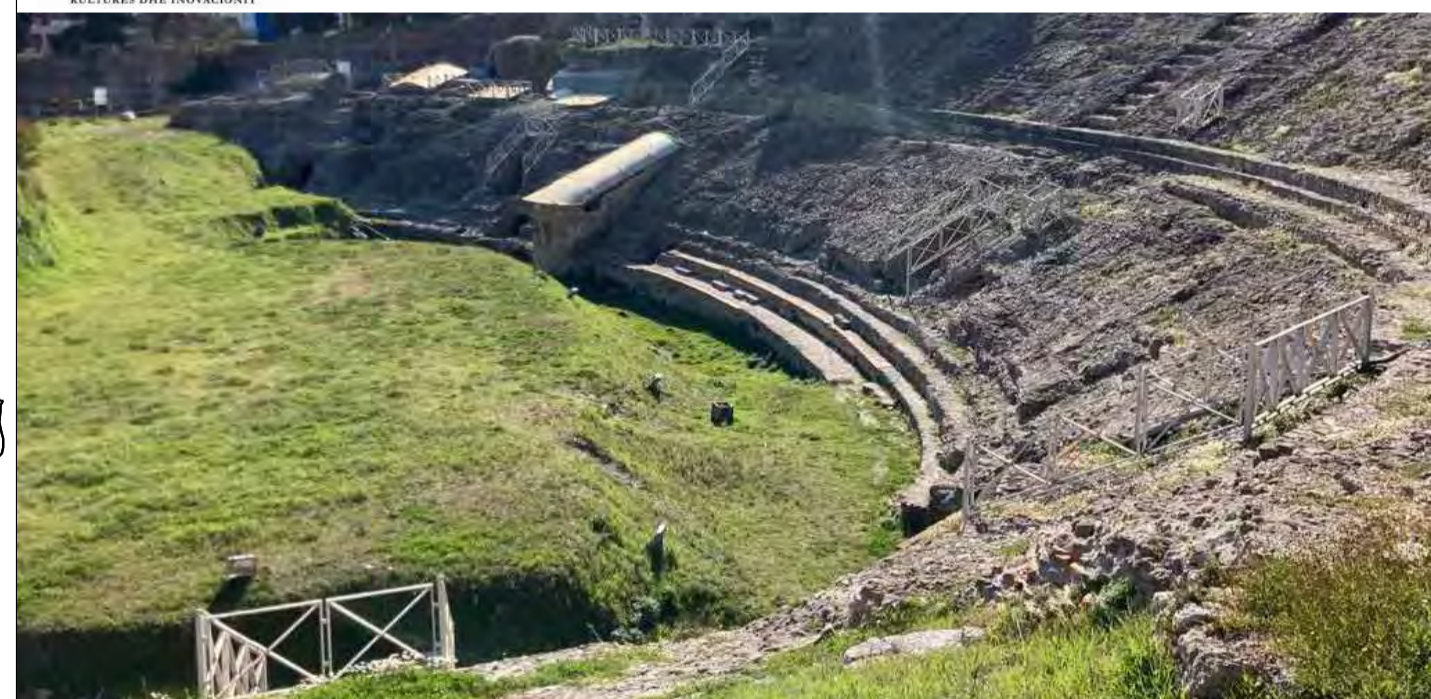
ELEVATION 7 west  
ELEVATION 7 perëndim

DECAY MAPPING - Amphitheatre of Durrës -  
MAPPING OF DECAY AND ALTERATIONS  
Elevation 7 West

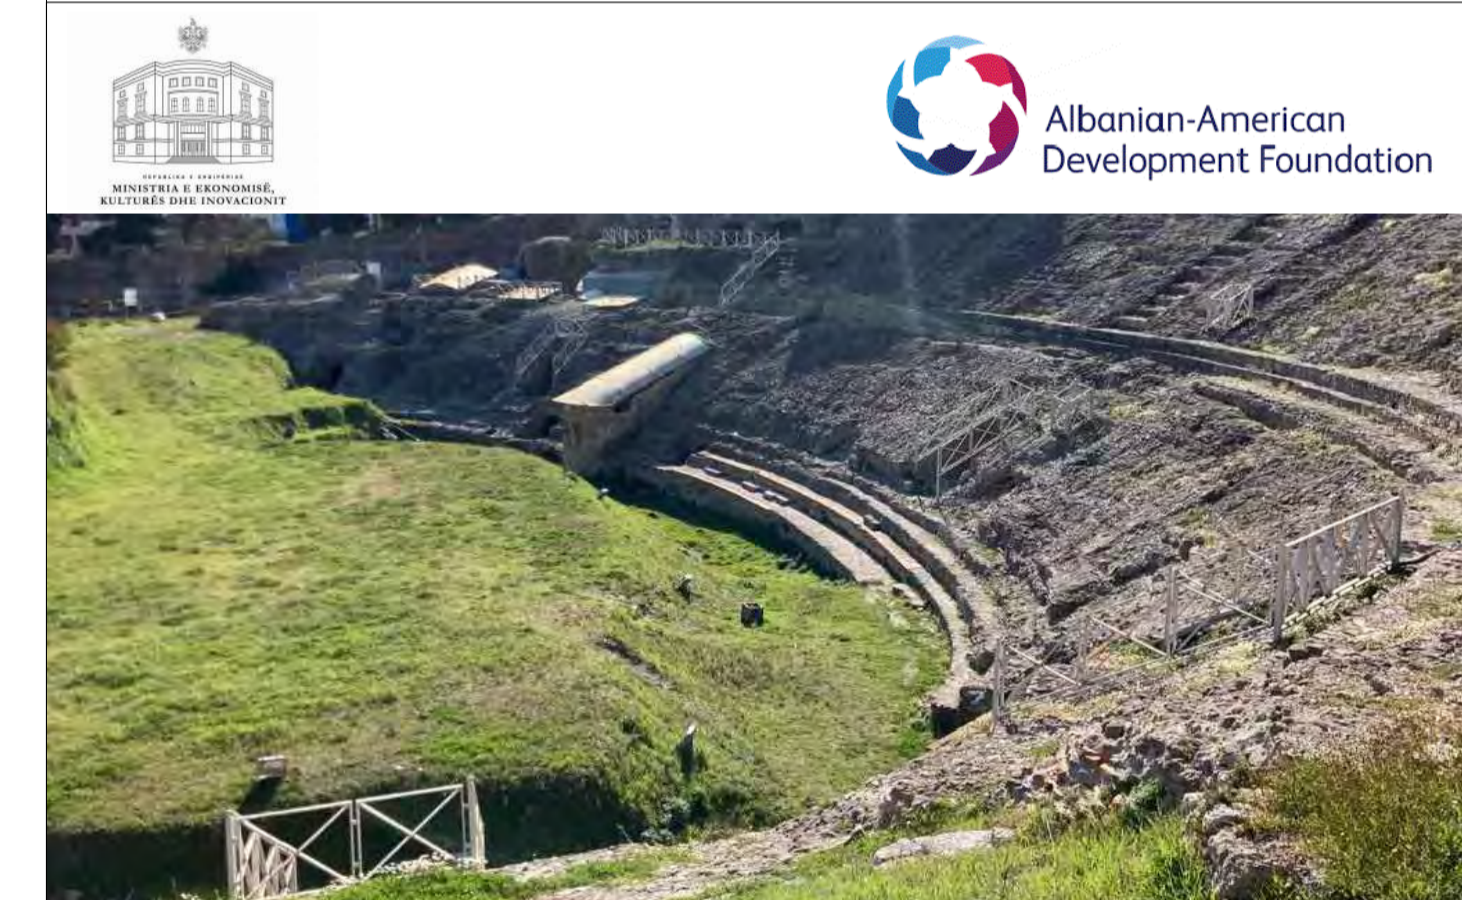
ELEVATION 1 south  
PRERJA 1 jug

DECAY MAPPING <b>- Amphitheatre of Durrës -</b> <b>MAPPING OF DECAY AND ALTERATIONS</b> Elevation 1 South	DATE: 2024 JUN sheet type <b>SECTION ELEVATION</b> sheet code <b>13</b> AM_DC_13 SCALE: 1:50
--	--
